Inspection Report Minerals Regulatory Program

Mine Name: Gold Queen/Million Dollar Gu	ulch	h
---	------	---

Permit number: S/017/035

Inspection Date: September 13, 2005

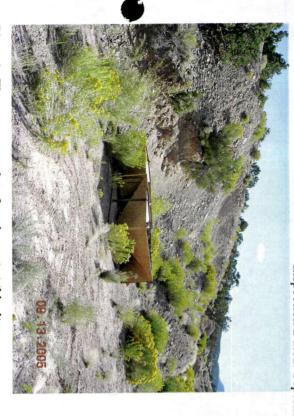
Photo 1. There was not a lot of equipment at this site.

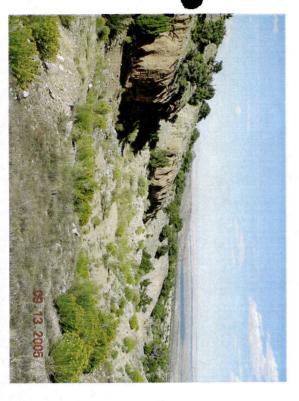
Photo 2. This is looking down toward the ponds. Note the steep sides of the gulch which could be backfilled with material from the ponds.

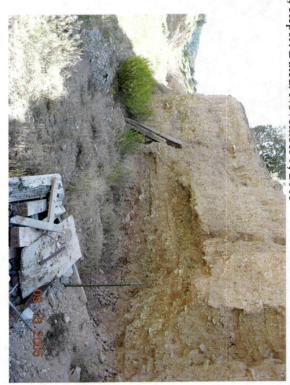
This is a placer operation where the operator mines and processes alluvial materials. Some of the banks that have been mined are vertical or nearly so, and one near the upper end of the site (Photo 3) has been undercut. There is evidence this was done by someone with hand tools and not by the operator.

Photo 3. An undercut bank that needs to be resloped, even if mining operations continue in this area.

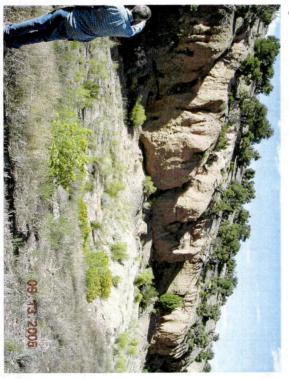
Photo 4. A breach in one of the ponds can be seen near the center of the photo. Note the steep sides of the gulch and the amount of erosion. Some of this erosion has been occurring since many years ago.
